Professional development programme™

Resene Professional development programme

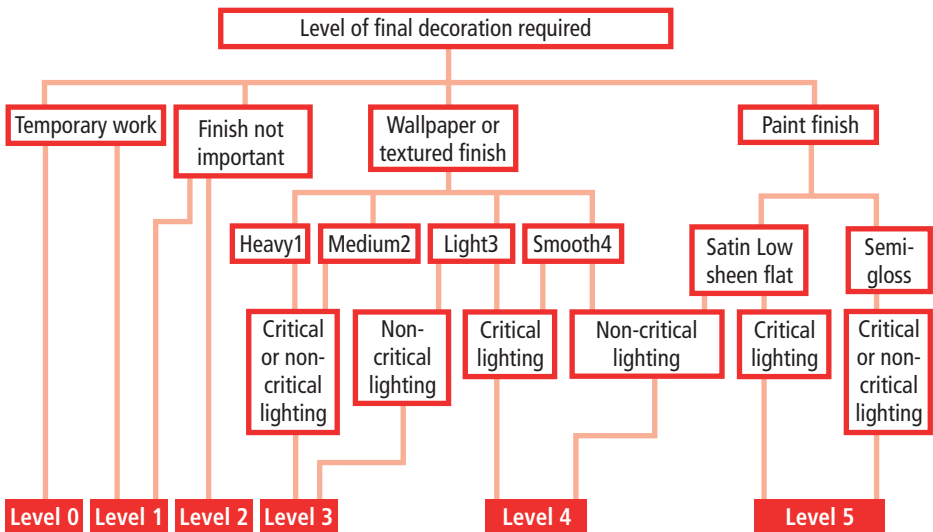
1: Heavy = a build-up of over 3mm.

2: Medium = a build-up of over 1mm up to and including 3mm.

3: Light = a build-up of over 1/2mm up to and including 1mm.

4: Smooth = a build-up of up to and including 1/2mm.

From: AS/NZ 2589.1

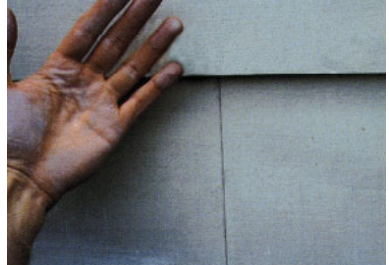
Chalking

Formation of fine powder on the surface of the paint film during weathering, which can cause colour fading. Although some degree of chalking is a normal, desirable way for a paint film to wear, excessive film erosion can result from heavy chalking.

- **Use of a low quality highly pigmented paint.**
- **Use of an interior paint for an outdoor application.**

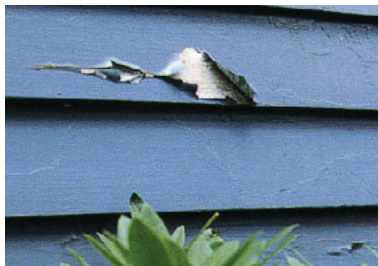
Peeling

Loss of paint due to poor adhesion. Where there is a primer and topcoat, or multiple coats of paint, peeling may involve some or all of the coats.

- **Seepage of moisture through uncaulked joints, worn caulk or leaks in roof or walls.**
- **Excess moisture escaping through the exterior walls (more likely if the paint is solventborne).**
- **Inadequate surface preparation.**
- **Use of lower quality paint.**
- **Applying a solventborne paint over a wet surface.**
- **Earlier blistering of paint (see Blistering).**

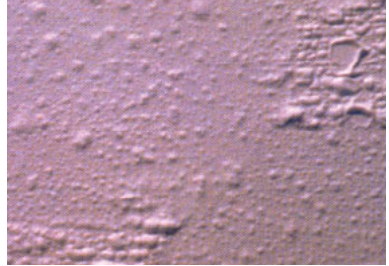
Blistering

Bubbles resulting from localised loss of adhesion and lifting of the paint film from the underlying surface.

- **Painting a warm surface in direct sunlight.**
- **Application of solventborne paint over a damp or wet surface.**
- **Moisture escaping through the exterior walls (less likely with waterborne paint than with solventborne paint)**
- **Exposure of waterborne paint film to dew, high humidity or rain shortly after paint has dried, especially if there was inadequate surface preparation.**

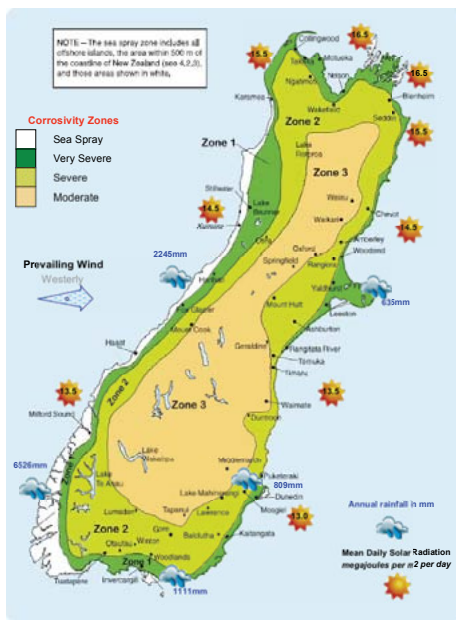
Environmental impacts on protection systems

For the purposes of selecting an appropriate protection system it is useful to classify the steel structure's environment according to the macroclimate overleaf. This figure shows which regions of New Zealand are more prone to marine deposition than others. While marine depositions (including salt) are not the only causes of protection system breakdown, they are often a large contributor.

- **Very severe** refers to regions where the rainfall is generally higher than 1000mm p.a. the average humidity is in excess of 70% and is subject to marine depositions of industrial pollution.
- **Severe** refers to regions where the rainfall is generally higher than 1000mm p.a. or has an average humidity in excess of 70% or slight marine deposition or industrial pollution.
- **Moderate** refers to regions where the rainfall is lower than 1000mm p.a., the average humidity is below 80%, there is no marine deposition and the area is remote from industrial activity or geothermal activity.
- **Special conditions** refers to the geothermal region of New Zealand.
