# Understanding Paint, what can go wrong?

## Introduction

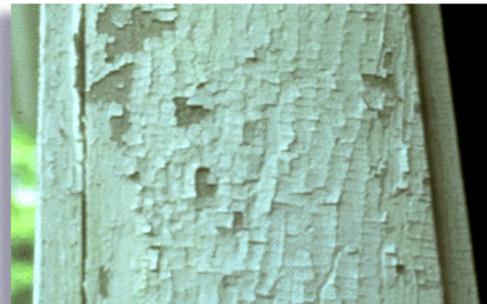
- **Flaking paint:** Flaking paint obviously occurs because there is a lack of adhesion somewhere in the paint system. The paint system includes each layer of old paint, the original primer and the surface layer of the substrate. A lack of adhesion may be present at any old paint or substrate layer and can be caused by a number of

factors. The most common is failure to wash away surface contaminants such as dirt, chalk, mould, grease, etc. A lack of adhesion may also result from the old paint or substrate being too hard or smooth to get a key for adhesion. Examples of this are old epoxy paints or old, unweathered, glossy solventborne paints. Sanding or the use of Resene Waterborne Smooth Surface Sealer ([See Data Sheet D47a](#)) avoids this problem. Another common cause of flaking paint is the presence of a poorly bound substrate. These substrates are identified by being easily removed by use of a light fingernail. Some typical examples are: Badly weathered timber where wood fibres are just sitting on the surface (sanding and Resene TimberLock ([See Data Sheet D48](#)) needed); Old badly weathered concrete on roofing tiles (Resene Sureseal ([See Data Sheet D42](#)) needed); Poor quality paperfaced plasterboard finishing compounds (Resene Sureseal needed).

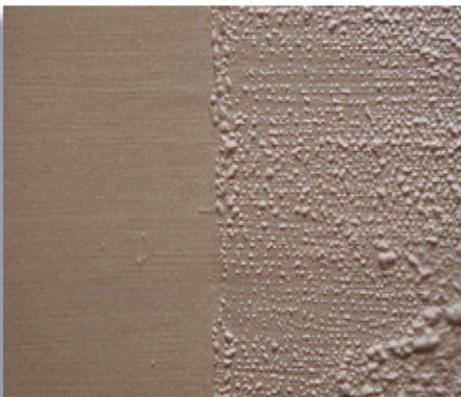
Very fine blisters such as are shown on half the panel (left) have been caused by the paint being caught by early rain or dew. They will probably settle down over time.

- **Blistering problems:** Blistering paint looks the same as your skin does if you get burnt. The paint skin bulges out in a circular bubble which can often be full of water. With solventborne paints the most usual cause is painting over wet substrates. This can also happen with Waterborne paints. A substrate may get wet later on as a result of a water leak (possible caused by failing flashings or sealants or even a burst water pipe inside a wall). Another cause of blistering waterborne paint is when it is caught by dew or rain before it has had time to dry properly. If these blisters are less than 1mm in diameter they may die back and never be seen again. This is one problem where procrastination can be rewarded.
